# DEVELOPMENT AND PROOF SERVICES ABERDEEN PROVING GROUND MARYLAND

TEST OF CARTRIDGE, 105-MM, APDS, T382 (U)

Second Report on Project FA-I/59-21

Dates of Test: June and July 1959

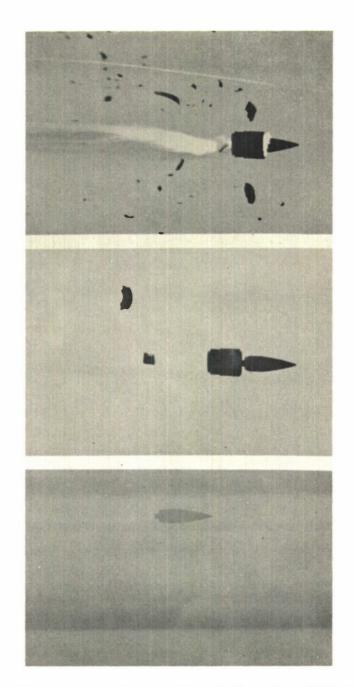
59T2830: Three smear photographs of Test Round 13 taken in flight. TOP TO BOTTOM: 15, 30 and 287 feet from Muzzle. Shot, Lot FA-E-441-2. Propellent Charge 12 1b, 10.5 oz.

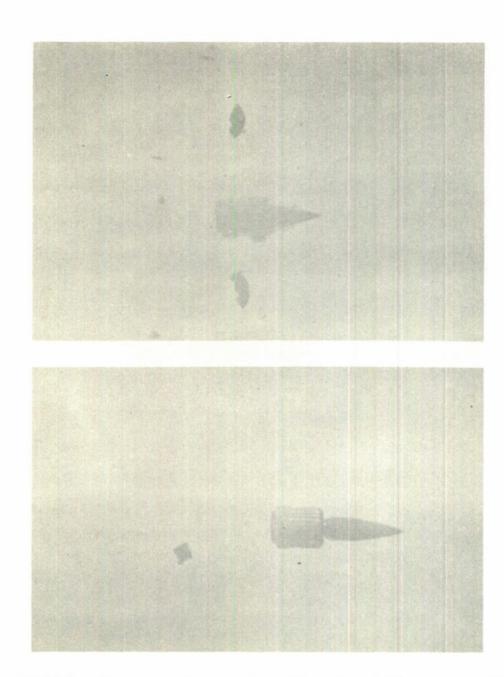
Test rounds 14 and 15 yielded complete penetrations, with round 14 showing no evidence of breakup. Round 15 may have had slight yaw, as evidenced by the yaw card.

59T2831: Two smear photographs of Test Round 14 taken in flight. TOP TO BOTTOM: 15 and 30 feet from Muzzle. Shot, Lot FA-E-441-1. Propellent Charge 12 lb, 4 oz.

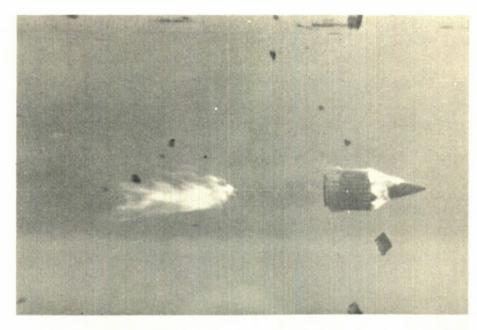
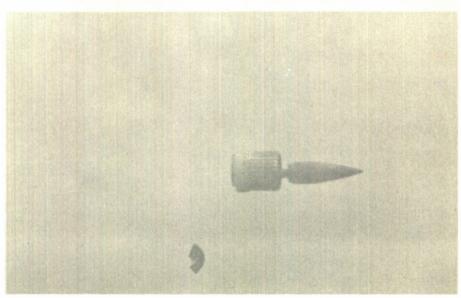
59T2832: Two smear photographs of Test Round 15 taken in flight. TOP TO BOTTOM: 15 and 30 feet from Muzzle. Shot, Lot FA-E-441-2. Propellent Charge 12 1b, 4 oz.

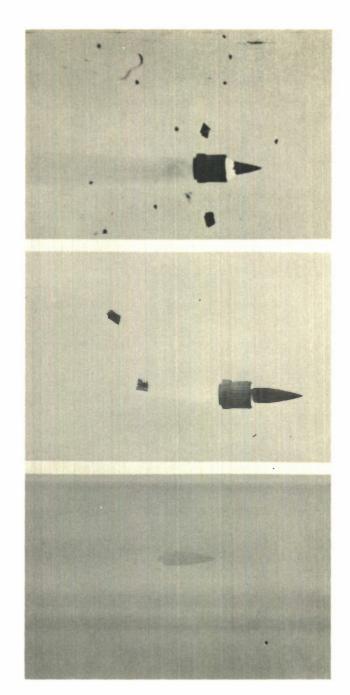
Test round 17 gave a complete penetration on the plate. Heavy engraving was noted on the carrier at the two camera positions near the gun.

59T2834: Three smear photographs of Test Round 17 taken in flight. TOP TO BOTTOM: 15, 30 and 267 feet from Muzzle. Shot, Lot FA-E-441-2. Propellent Charge 12 lb, 4 oz.

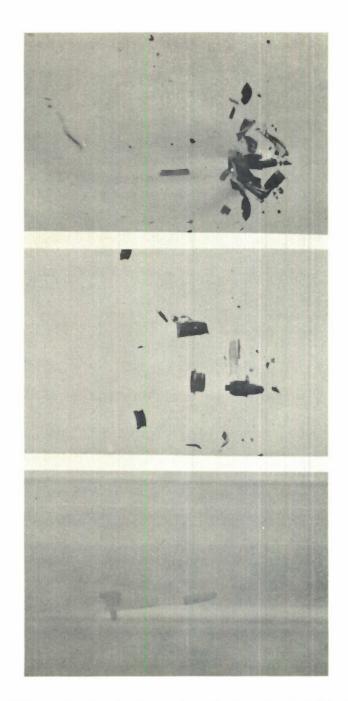
Test round 18 broke up completely either on setback or on emergence from the tube. Small fragments of the recovered forward sheath show that the center, between the tip and the threaded portion, was crushed, presumably by the petals on setback.

59T2835: Three smear photographs of Test Round 18 taken in flight, showing breakup of shot. TOP TO BOTTOM: 15, 30 and 287 feet from Muzzle. Shot, Lot FA-E-441-1. Propellent Charge 12 1b, 4 oz.

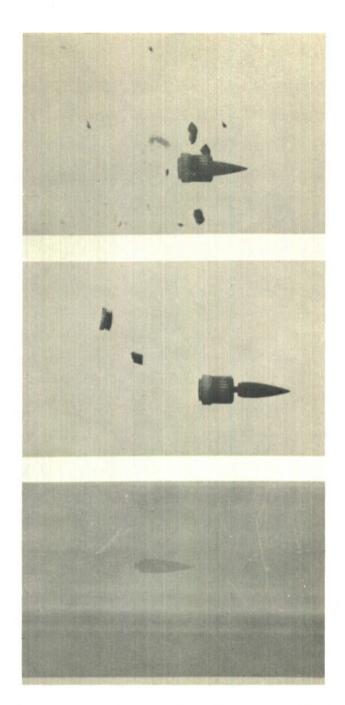
Test round 19 produced a complete penetration on the plate which created a bulge first and then "knocked" off the cap of the bulge. The size of the exit hole was the smallest observed in the firing. Test rounds 20 and 21 both yielded partial penetrations, but showed satisfactory flight characteristics prior to impact on the yaw card. Round 20 deviated from the expected trajectory, impacting 4 feet above the point of aim. Approximately three degrees of subprojectile yaw were observed on the yaw card. No yaw was observed from round 21. The bulge on the rear of the plate had a crack around the right side of the bulge 7.75 inches in length. The width of the crack was approximately 0.031 inch in width, maximum.

59T2836: Three smear photographs of Test Round 19 taken in flight. TOP TO BOTTOM: 15, 30 and 287 feet from Muzzle. Shot, Lot FA-E-441-2. Propellent Charge 12 1b, 4 oz.

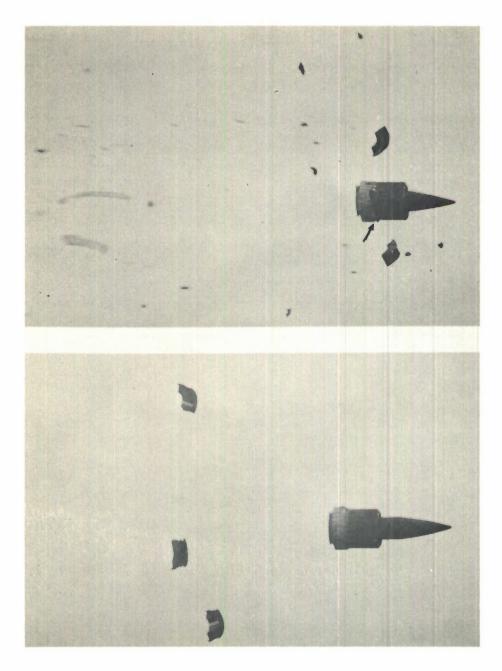
59T2837: Two smear photographs of Test Round 20 taken in flight. TOP TO BOTTOM: 15, 30 feet from Muzzle. Shot, Lot FA-E-441-1. Propellent Charge 12 lb, 4 oz. Arrow in top photograph indicates petal beside carrier.

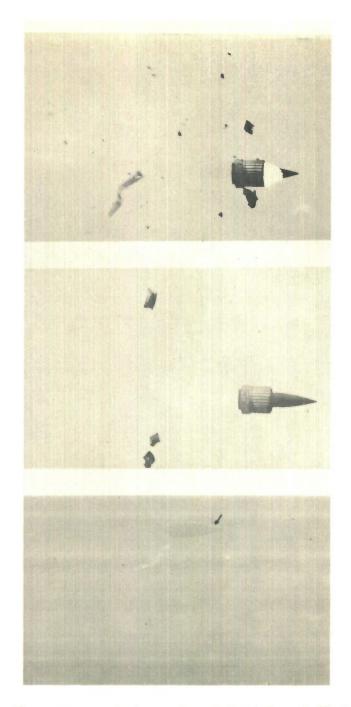
59T2838: Three smear photographs of Test Round 21 taken in flight. TOP TO BOTTOM: 15, 30 and 287 feet from Muzzle. Shot, Lot FA-E-441-2. Propellent Charge 12 lb, 4 oz. Arrow in bottom photograph indicates deformation on forward sheath of subprojectile.

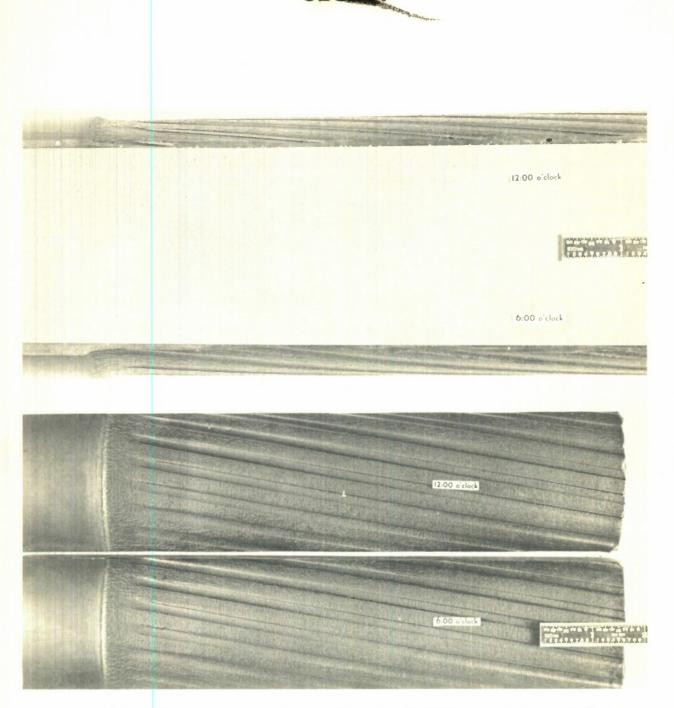
The test was suspended to permit an examination of the tube for damage incurred by the breakup of the shot during shot travel. Several gouges and lands cut by the passage of metal were noticed forward of the origin of rifling. It was felt that the damage would not affect projectile launching, and firing was resumed.

59T2432 Impressions Showing Condition of Rifling at Origin at 6 and 12:00 O'Clock, after Firing 87 Rounds.

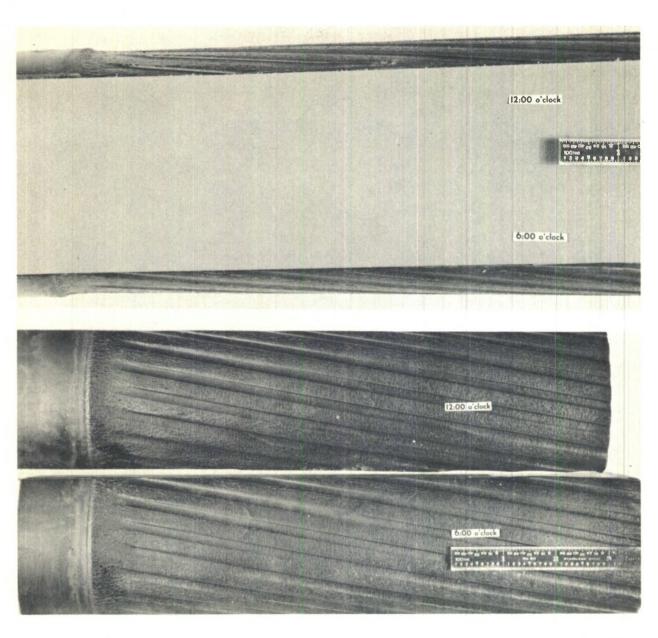
59T2433 Impressions Showing Condition of Rifling at Origin at 12:00 and 6:00 O'Clock, after Firing 97 Rounds.

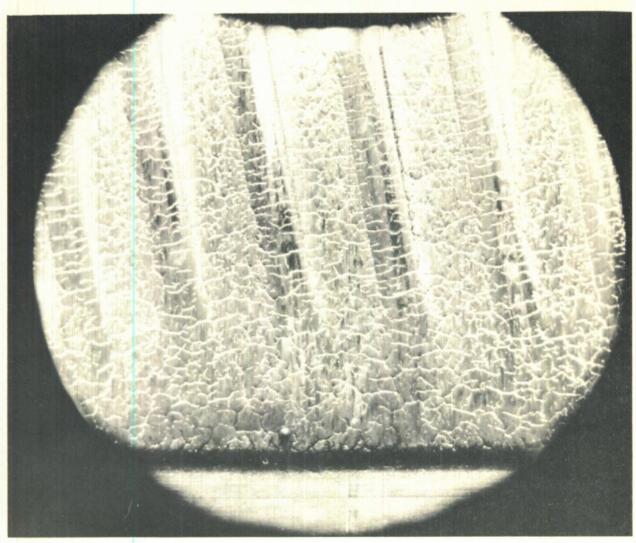
59T2319 Bore Photograph Showing Condition of Rifling at Origin at 6:00 O'Clock, after Firing 87 Rounds.

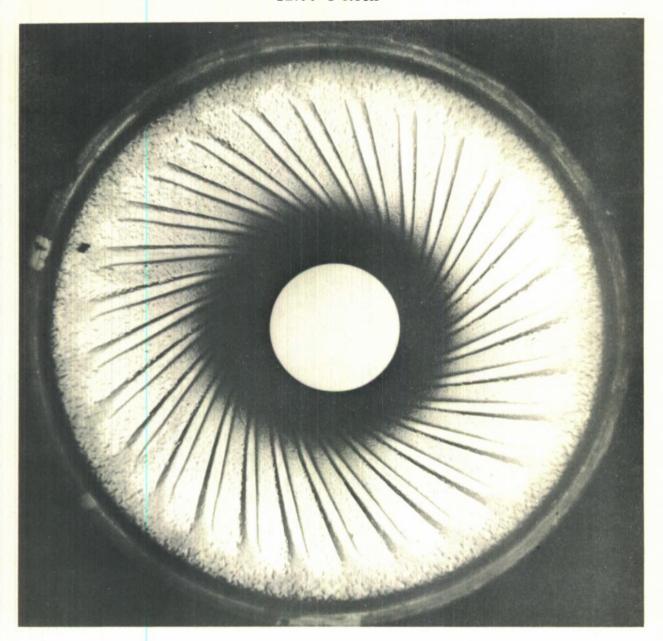
59T232l Bore Photograph Showing Condition of Rifling at Origin, after Firing 87 Rounds.

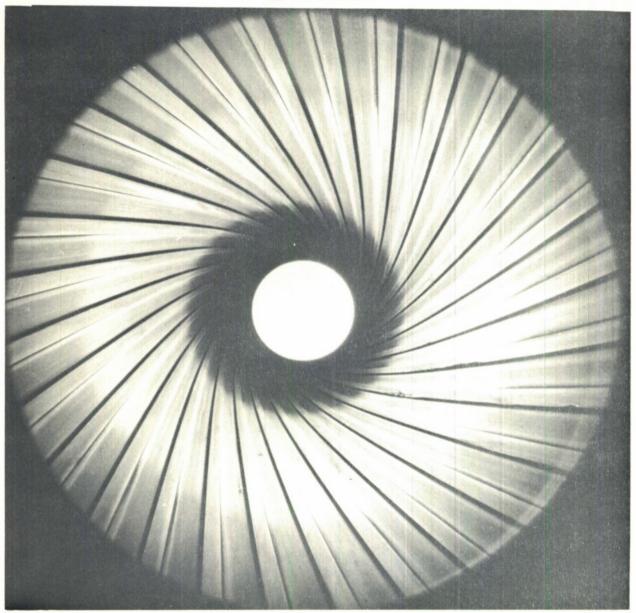
59T2322 Bore Photograph Showing Condition of Rifling from 147.00 in. to 160.00 in. from Rear Face of Tube, after Firing  $87\ \rm Rounds$  .

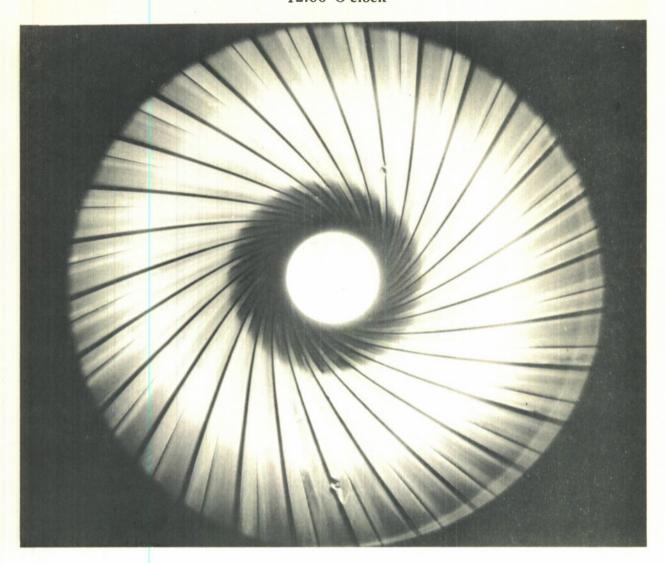
59T2323 Bore Photograph Showing Condition of Rifling from 170.00 in. to 178.00 in. from Rear Face of Tube, after Firing 87 Rounds.

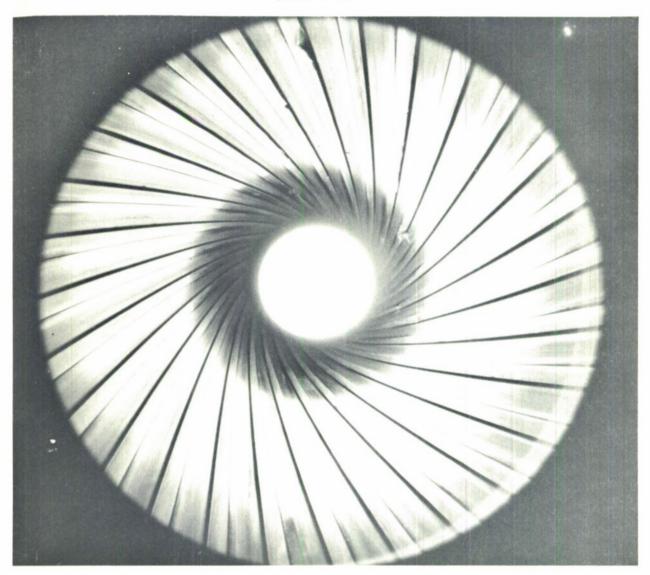
59T2324 Bore Photograph Showing Condition of Rifling from 178.00 into 184.00 in. from Rear Face of Tube, after Firing  $87\ \rm Rounds$  .

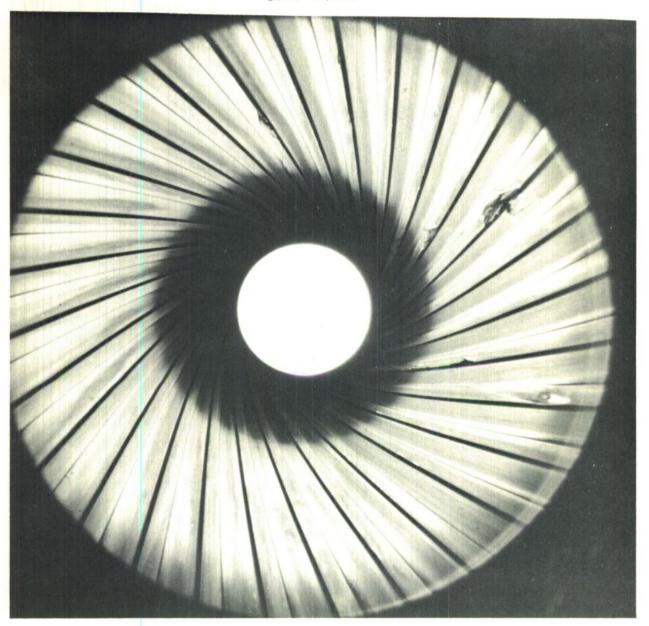
59T2325 Bore Photograph Showing Condition of Rifling from 184.00 in. to 190.00 in. from Rear Face of Tube, after Firing 87 Rounds.

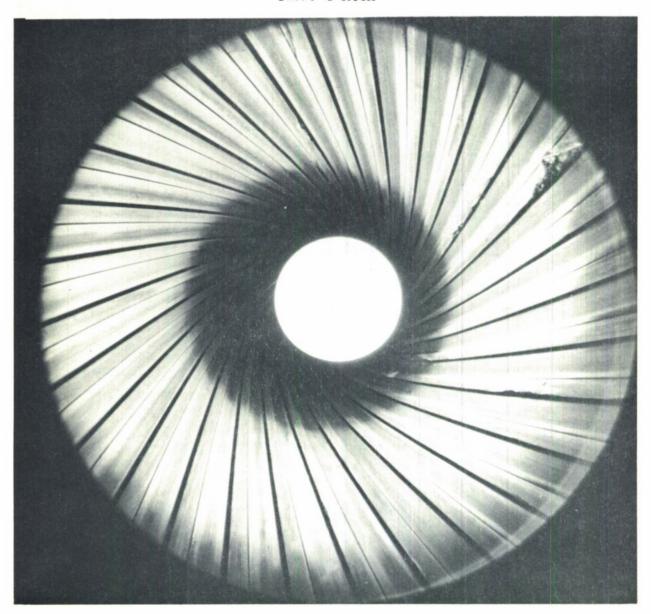
59T2326~ Bore Photograph Showing Condition of Rifling from 190.00 in. to 198.00 in. from Rear Face of Tube, after Firing  $87~{\rm Rounds}\,.$

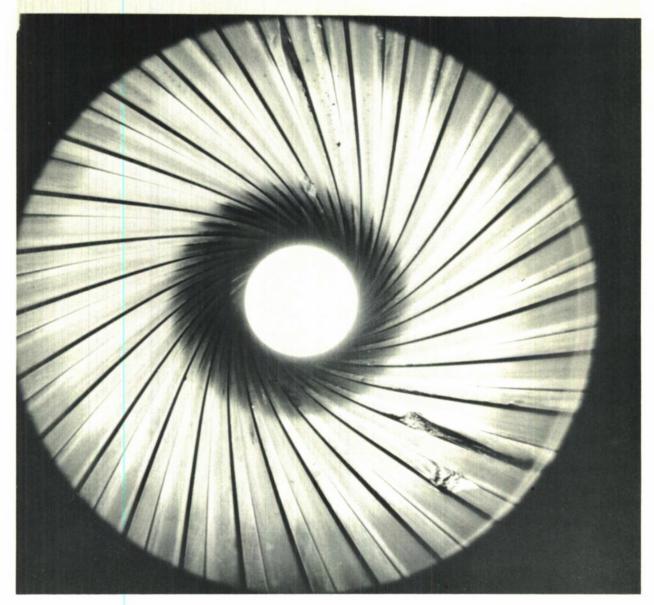
59T2327 Bore Photograph Showing Condition of Rifling from 198.00 in. to 206.00 in. from Rear Face of Tube, after Firing 87 Rounds.
